INVESTIGATION NO. 3060

CHICAGO, MILWAUKEE, ST. PAUL AND PACIFIC
RAILROAD COMPANY

REPORT IN RE ACCIDENT

NEAR CEDAR FALLS, WASH., ON

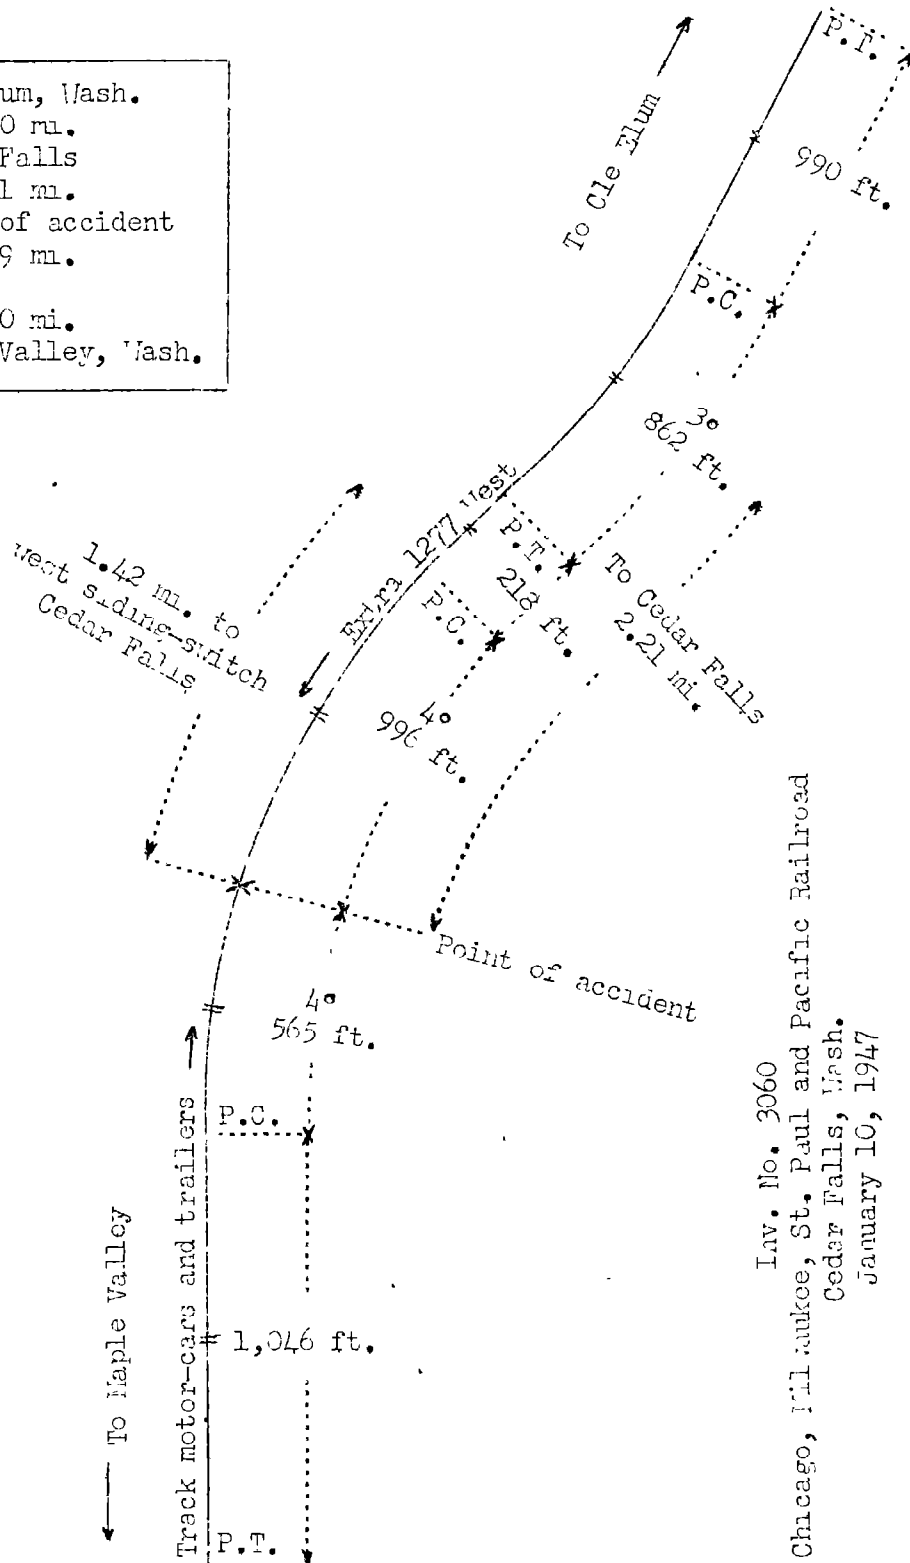
Inv. No. 3060
 Chicago, Milwaukee, St. Paul and Pacific Railroad
 Cedar Falls, Wash.
 January 10, 1947

o	Cle Elum, Wash.	50.80 mi.
o	Cedar Falls	2.21 mi.
X	Point of accident	11.39 mi.
o	Noble	3.40 mi.
o	Maple Valley, Wash.

This accident occurred on that part of the Coast Division extending between Cle Elum and Maple Valley, Wash., 67.8 miles, a single-track line, equipped with an overhead catenary system for the electric propulsion of trains, over which trains are operated by timetable, train orders and an automatic block-signal system. At Cedar Falls, 50.8 miles west of Cle Elum, a siding 1.12 miles in length parallels the main track on the north. The west switch of this siding is 4,153 feet west of the station. The accident occurred on the main track 1.42 miles west of the west siding-switch. From the east there are, in succession a tangent 990 feet in length, a 3° curve to the right 862 feet, a tangent 218 feet and a 4° curve to the left 996 feet to the point of accident and 565 feet westward. From the west there is a tangent 1,046 feet in length, which is followed by the curve on which the accident occurred. The grade is 0.64 percent descending westward.

Because of an embankment on the inside of the curve on which the accident occurred, the view of the point of accident from either direction was restricted to a distance of about 200 feet.
