Dispatch

Dedicated to the historic preservation and/or modeling of the former CMStP&P/Milw. "Lines West"

Volume 6, Issue No. 1

January 1993

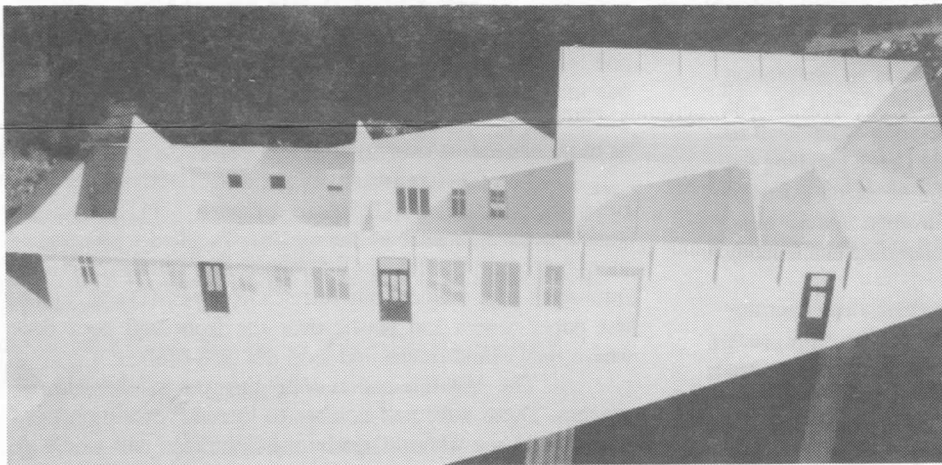
Subroof assembly ready for installation above baggage room end. Note knee brace members cemented to subroof assembly and to exterior walls.

Construct a subroof assembly of .045" styrene to cover the baggage room and other areas under the lower roof line. Install temporarily, tacking with cement.

Second legs of the knee brace assemblies are now constructed and cemented to the underside all of the completed subroof sections. The second legs are made in the same way as the vertical legs, each leg having a notch and concave pointed end. Each second leg abuts a corresponding vertical leg. This match is aided by the temporary installation of the baggage room end subroof assembly.

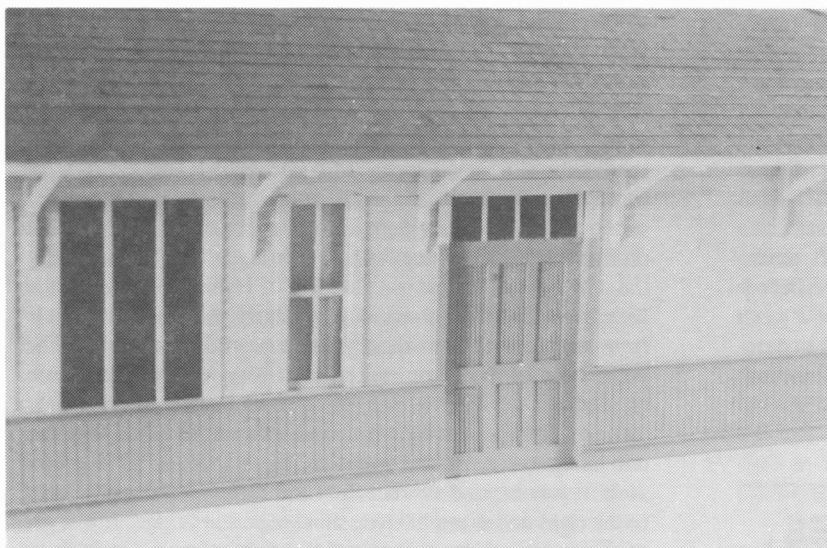
Baggage room door, a scratchbuilt model of one of the prototype's two original doors. It has four baggage doors total.

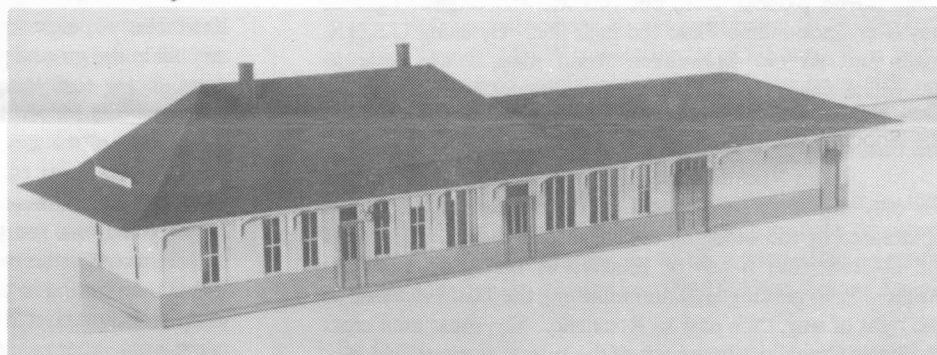
Completed depot model, front view

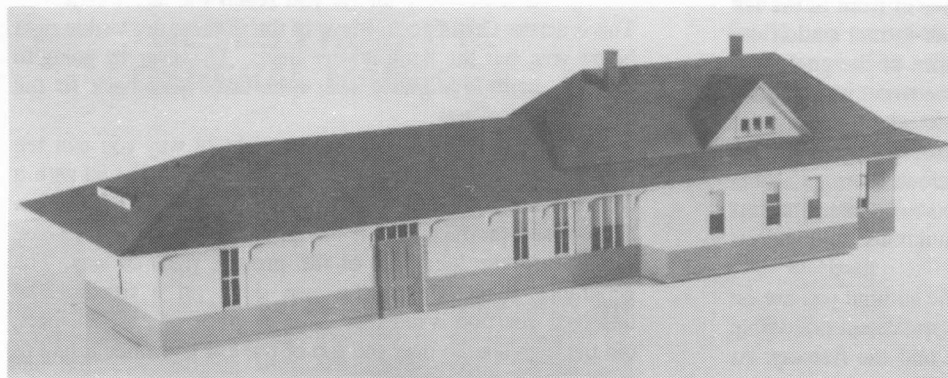
Completed depot, rear view

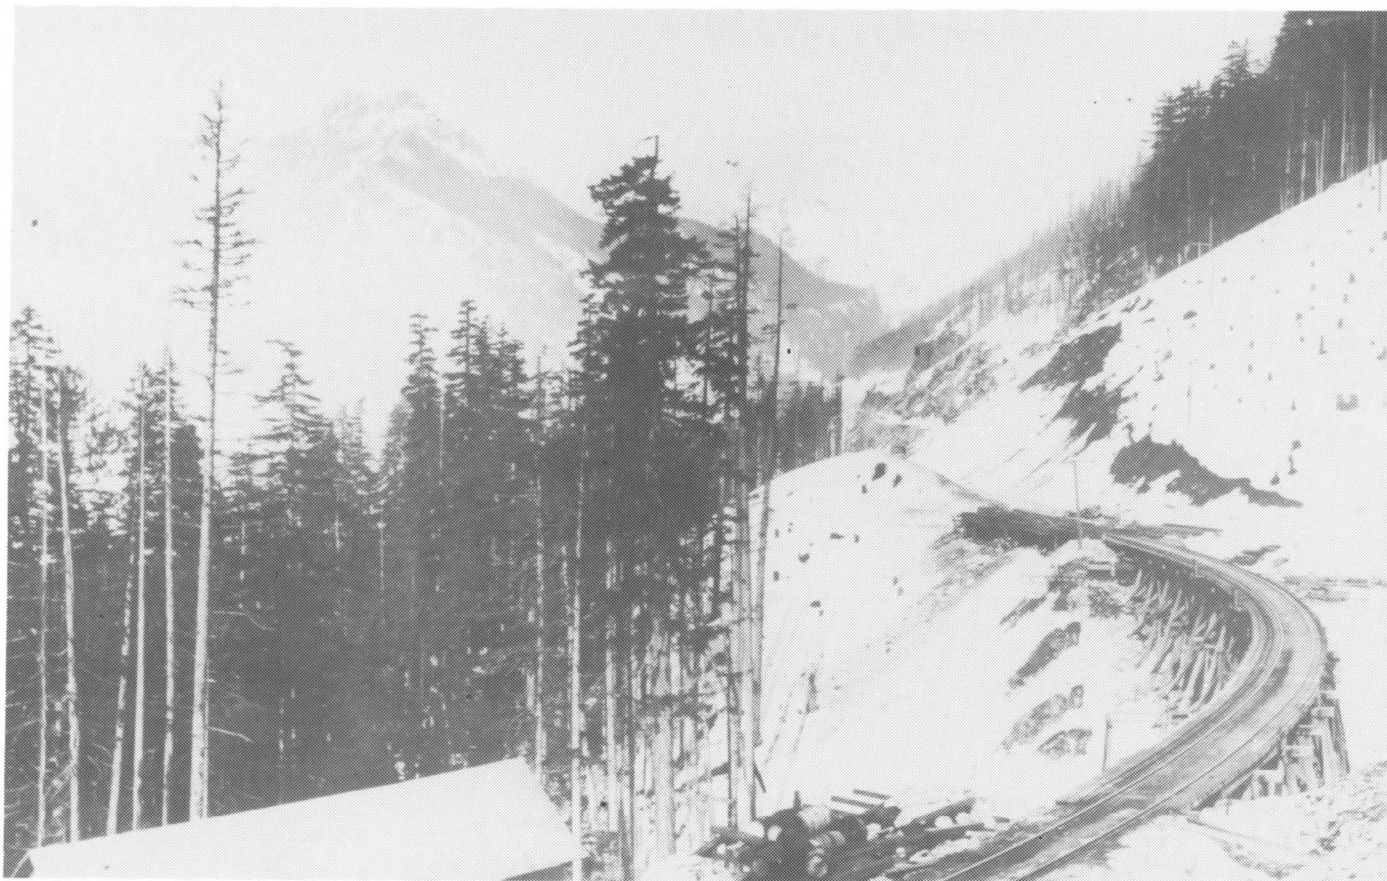
Rockdale looking east, Rockdale Creek Trestle in Foreground. Tunnel is under construction to right, circa 1912-1914.
Photo courtesy of Doug Nighswonger.

From Rockdale the right of way is fairly discernable for only about three quarters of a mile before the line is obliterated by the widening of I-90 located below. This part I did not hike, but it can be reached by hiking up from the Asahel Curtis parking area and following the Lost Lake trail to the right of way, then east to Rockdale. You must then cross Rockdale Creek just to the left of the tunnel entrance and pick up the right of way on the other side. Remains of the original trestle over the creek can still be seen giving you a reference point to start from.

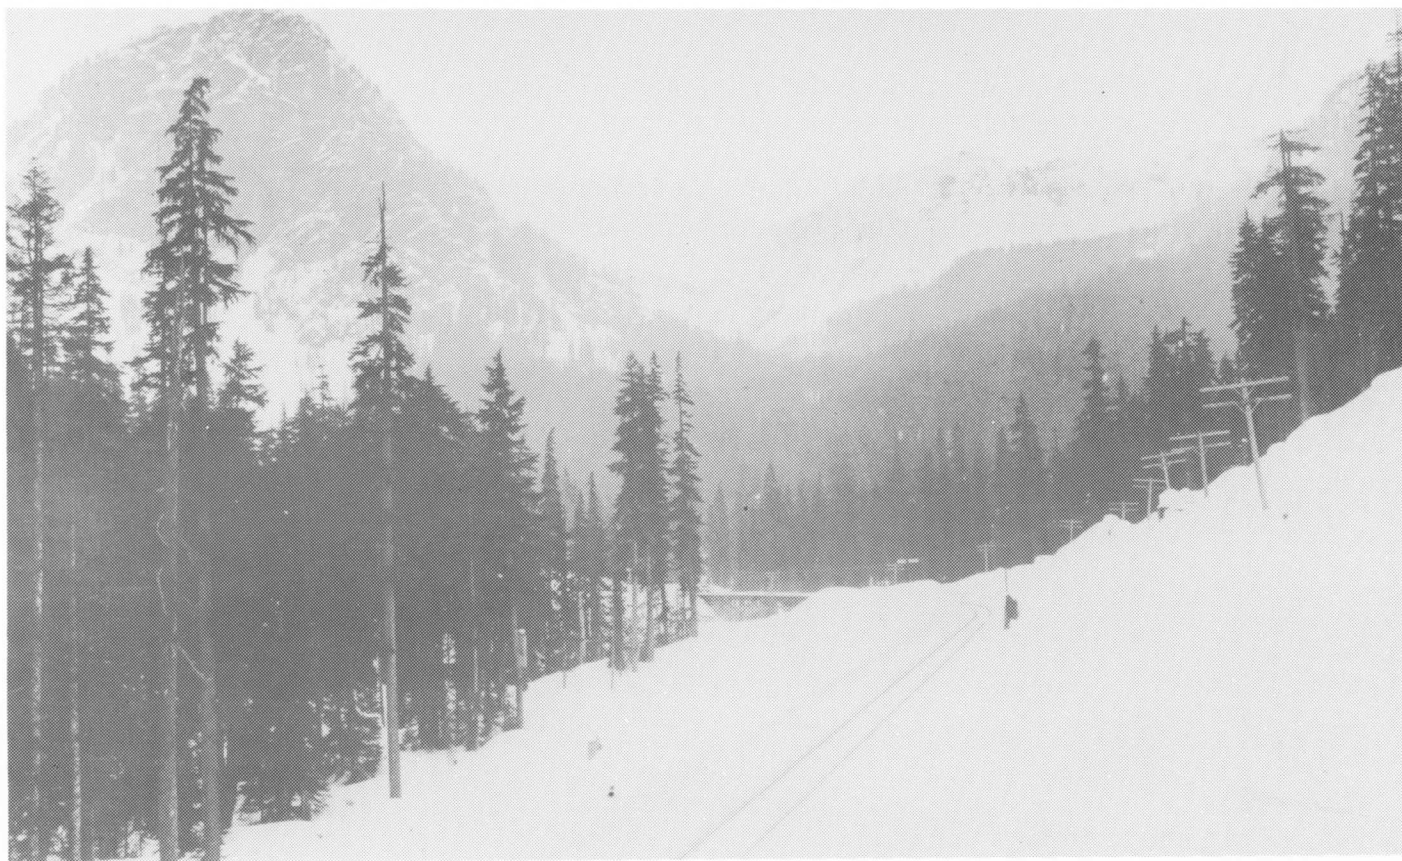
Trestle over creek and original Snoqualmie Pass Hwy located one mile west of Laconia, looking east with Mt. Snoqualmie to the right. Photo courtesy of Doug Nighswonger.

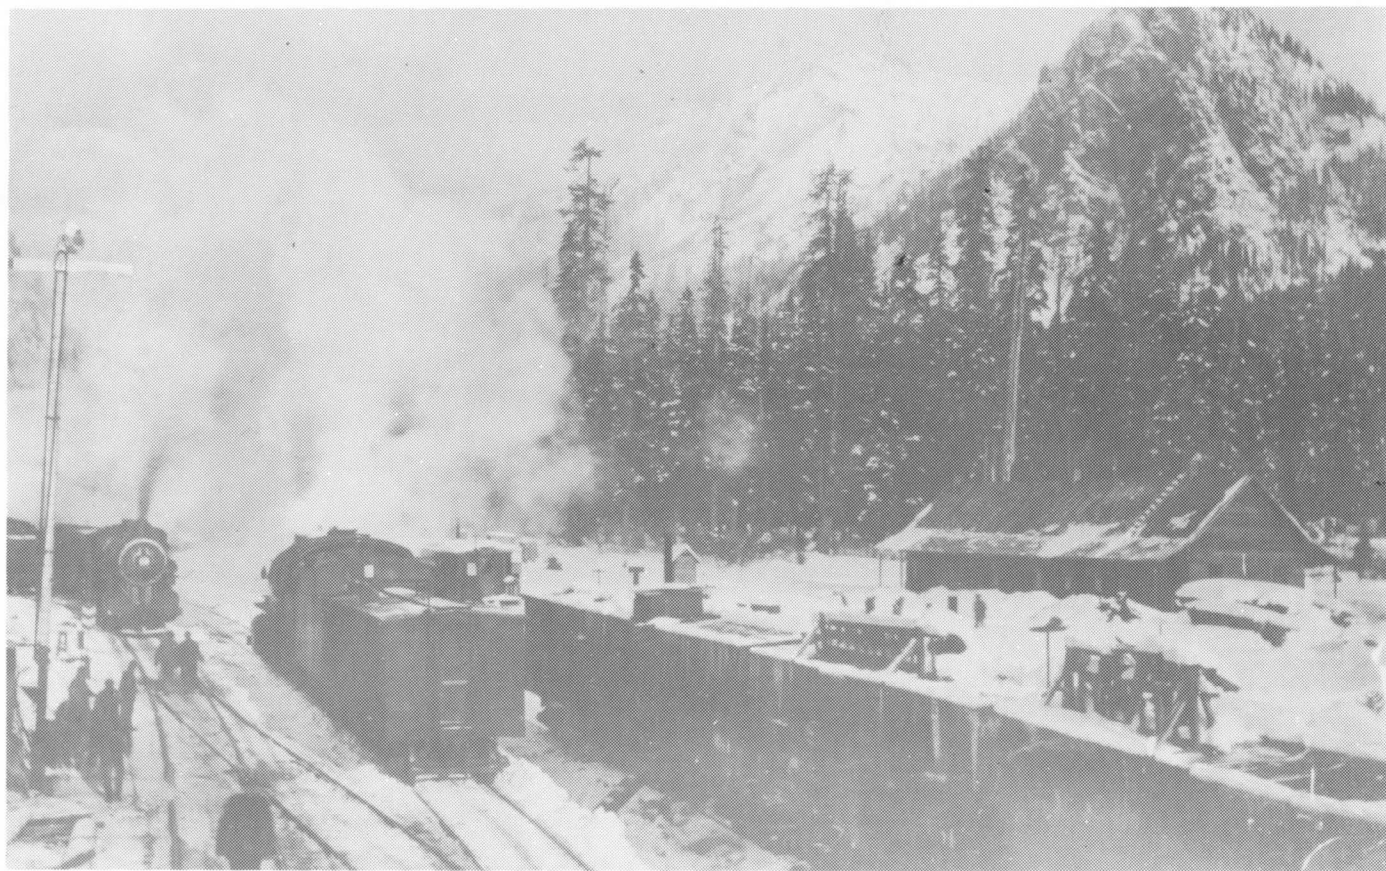
Laconia, winter 1908-1909, looking west. Water tank is not yet built. Telegraph office is open. An eastbound train is here and a helper engine is waiting on the siding. Photo courtesy of Doug Nighswonger.
